Pathologies of concrete in Saint-Vincent Neo-Byzantine Church and Pauchot reinforced artificial stone

This article focuses on the Saint-Vincent Church, Liege district, Belgium. With concrete as major building material, this was built in only 20 months, from 1928 to 1930. This monumental building, from Neo Byzantine style, however presents some degradations. A visual inspection, as well as non destructive and laboratory tests, are presented and analysed. They help to make a clear diagnosis and to assess hypothesis on the real state of this high-quality architectural building. Moreover, specific investigations have been realized on a special mortar used for wall construction: Pauchot reinforced artificial stone.

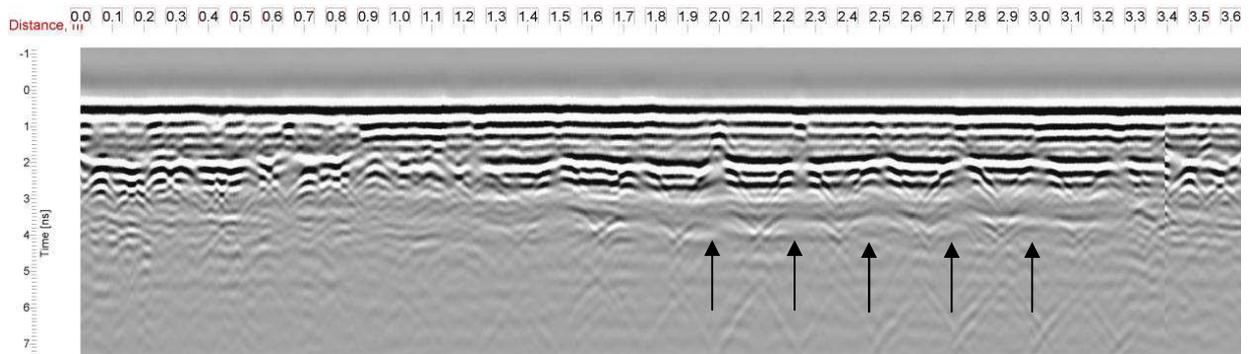
Figure 17. Saint-Vincent Church: radar signal obtained in the stair case, under spalling visible in Figure 18

In Figure 17 a horizontal reflector is observed at a depth of 12 cm (for a speed of 13 cm/ns). It is probably the void behind the wall, under the apparent lattice visible in Figure 18 (situation as sample 1(Figure 6)). At the level of these reflectors are semi-hyperbolic waves (\uparrow), which is consistent with the presence of joints and probably indicate the presence of blocks.

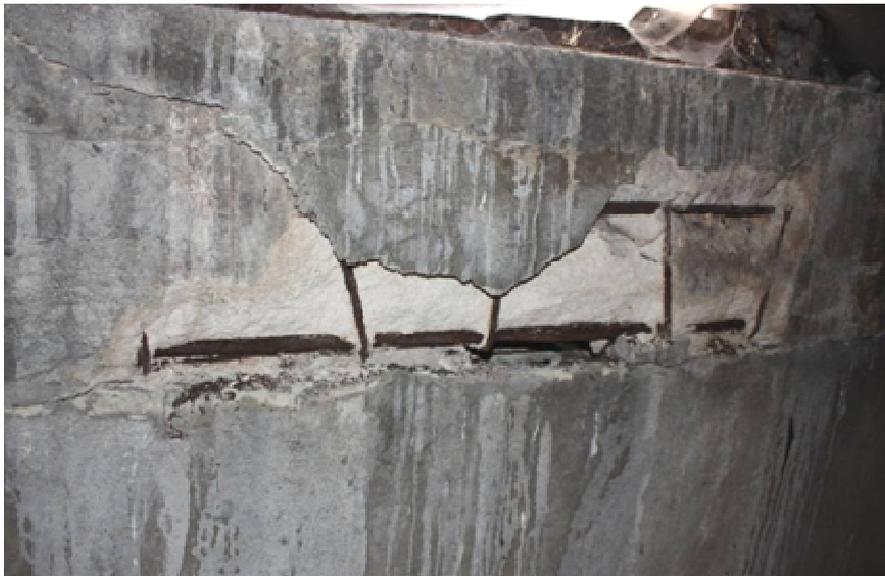
Figure 18. Spalling of Pauchot reinforced artificial stone (staircases, Saint-Vincent church).

In addition, spalling was found as a main degradation all along the facade of the church (Figure 23), particularly around bays (Figure 24). At this level, the cover of steel reinforcement is sometimes very thin (Figures 25 and 26). Other traces of spalling were visible in the stairwell and under the central dome (Figure 13). Between the arches spanning the nave and the lantern, corroded steel bars are also flushing with concrete skin.

Carbonation depth and thin steel reinforcement cover seem to be the main causes of spalling.

Degradations pointed out in Saint-Vincent church could be solved by removing of the carbonated concrete, specifically Pauchot reinforced artificial stone, protecting steel rebars from corrosion and applying a less porous mortar as cover material.

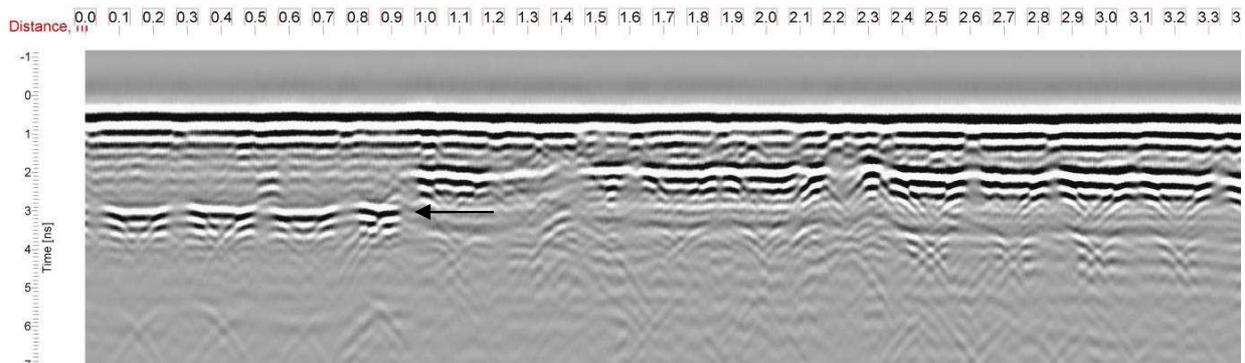
On the recorded signal at the base of the staircase (Figure 19), there is a horizontal reflector and regularly spaced frames in the right part. On the left, a reflector is marked down: it could correspond to the transition from Pauchot reinforced artificial stone and a concrete wall, probably composed of blocks, which is attested once again by the presence of half-hyperbolas evenly spaced at the horizontal reflector (\leftarrow).

Figure 19. Saint-Vincent Church: radar signal obtained at the base of the staircase

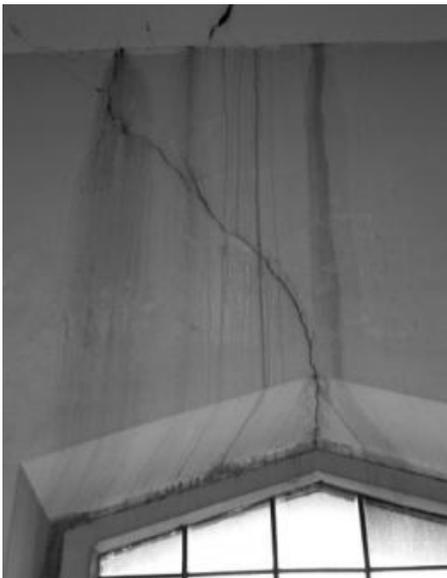
- cracks without specific direction, in front of the monument or on the top of windows (Figure 20),
- oblique cracks on the beams between the pillars of the rotunda or the pillars of the apses or
- vertical cracks on some of the pillars of apses (Figure 21).

Figure 20. Crack in the central part of the beam above the by lighting the gallery (East front, Saint-Vincent Church)

- structural defects are visible, mainly in the form of cracks due to differential movements of parts of the structures. These differential displacements may be due to soil settlements or thermal gradients;

The origin of other vertical cracks however could not be yet identified on the basis of available information. In all cases, the installation of plaster witnesses would confirm a potential movement of the cracks. It will be followed, if necessary, by the installation of sensors, recording the movement of the lips of the cracks, providing the evolution of this movement over time.

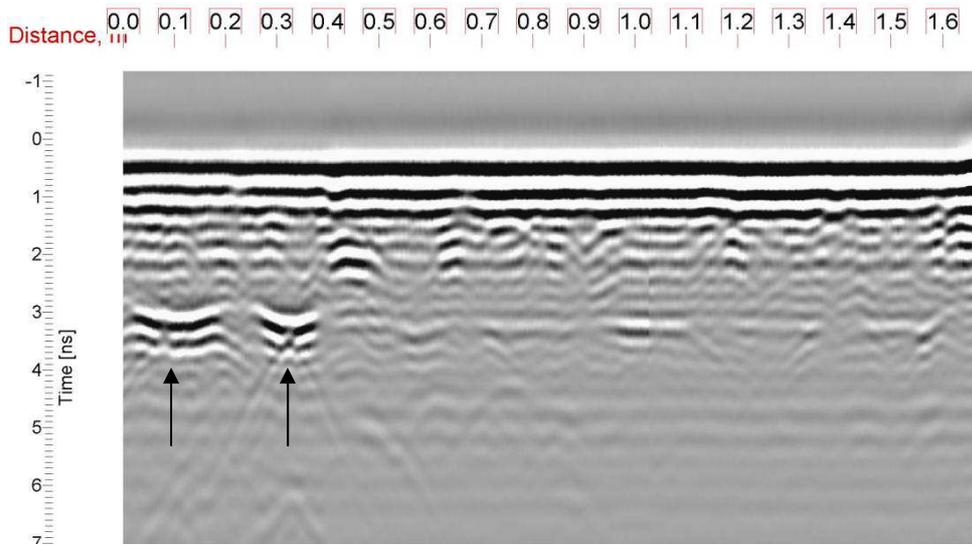
These last one may be related to the presence (confirmed by radar [18, 19]) of metal pipes discharging rainwater from the central dome. The position of the vertical cracks visible on the front of the pillars coincides with the hyperboles (\uparrow) identified by the radar (Figure 22). This would support the hypothesis attributing the presence of cracks to a deformation of the pipes, maybe caused by insufficient flow diameter.

Figure 22. Saint-Vincent Church: radar signal obtained from pillar between West and South-West apses.

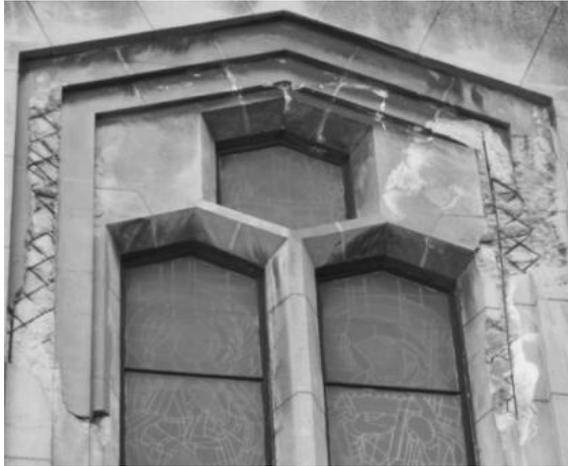
Figure 23. Spallings around the North West bay of the choir, Saint-Vincent Church

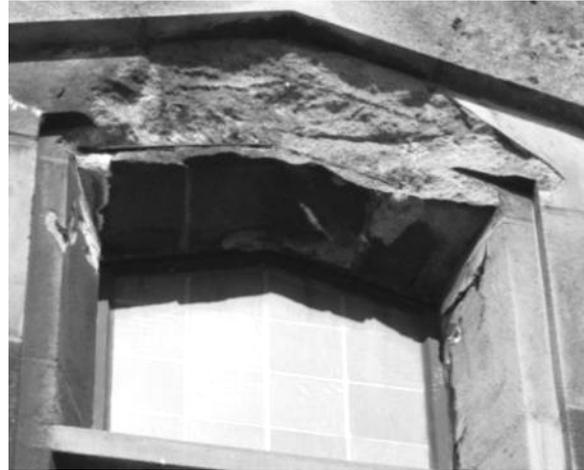
Figure 2'. Spallings around a North bay, Saint-Vincent Church

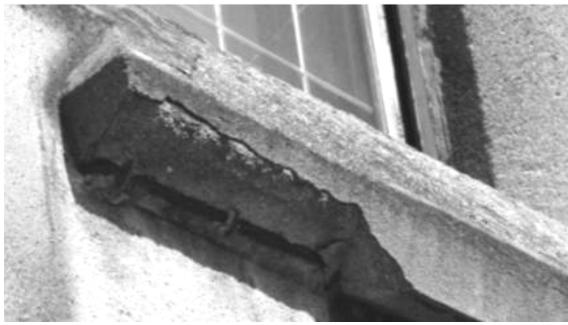
Figure 25. Spallings under window sill, Saint-Vincent Church

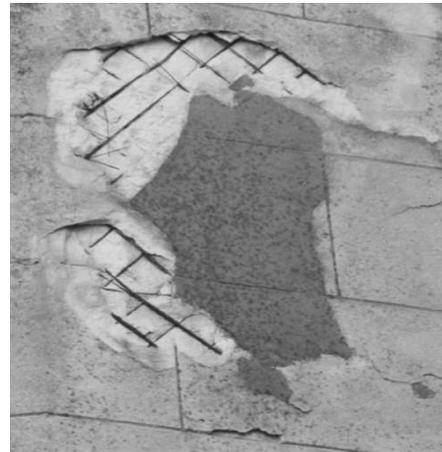
Spalling (Figs. 23 to 26) means the debonding of pieces of concrete from their support. The dissociation follows tensile stresses into concrete, often caused by corrosion of steel reinforcement [22, 23]. The problem may be further amplified by an action of frost on an area saturated with water.

Corrosion of steel (Figs. 23 and 26) can be due to an attack by chlorides (from de-icing salts or accelerators) or the carbonation of concrete surrounding the reinforcement [24]. Too low cover of reinforcement promotes the corrosion reaction [25]. Finally, the disintegration of the concrete may also result from an attack by bacteria or acid products.

Figure 26. Typical spalling inside Pauchot reinforced artificial stone, North West apse, Saint-Vincent Church

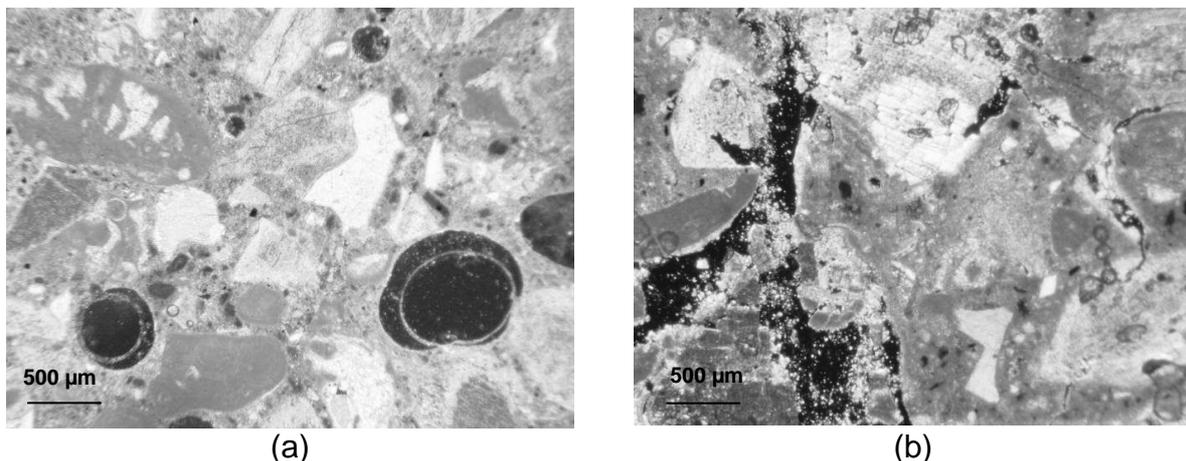
Large air bubbles and voids are observed on thin slices samples (Figure 27). Limestone sand seems have been used and CaCO_3 crystals are numerous (Figure 29): this is probably due to high lime content for preparing mortar. Cement is however largely present in some samples, attesting the use of this hydraulic binder. The structure is lumpy. The grains of carbonates can be detached from the cement paste. Lime can be carbonated. There is no cohesion in cement paste and the interface between the grains of limestone is often broken (Figure 28).

Figure 27. Optical microscope on Pauchot artificial stone - (a) sample 1 and (b) sample 3.

The chemical and physical tests (Table 1) and microscopical observations (Figures 27 to 29) carried out on samples of Pauchot reinforced artificial stone revealed a heterogeneous material composition, more similar to a mortar or light concrete than a conventional reinforced concrete. It is porous and offers a compressive strength ranging from 11.1 to 20.9 MPa. The chemical analysis revealed a very low chloride concentration, eliminating the risk of corrosion attack of chlorides for these samples and favoring the hypothesis of corrosion by carbonation (the more likely that porosity of the artificial Pauchot stone is important and the urban environment in which the church is polluted).

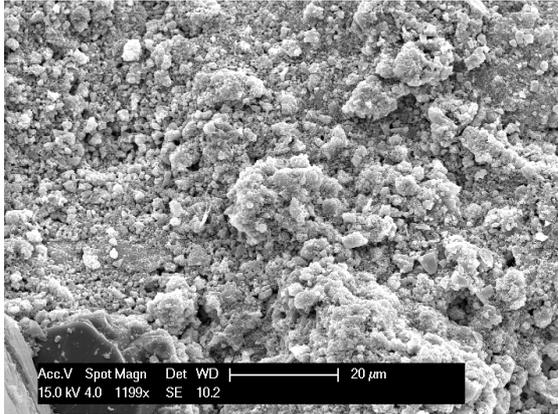
Figure 28. Cementitious matrix from Pauchot artificial stone (view ESEM – sample 3)

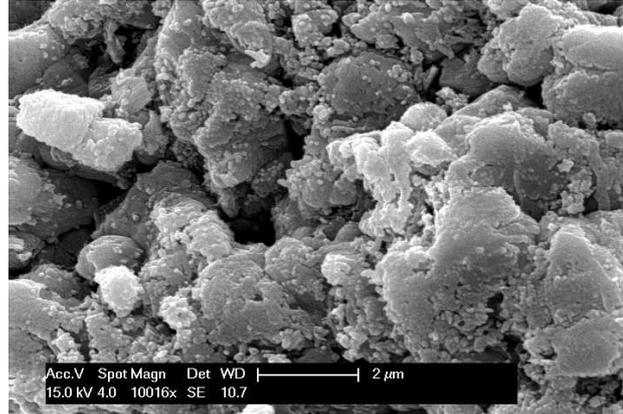
Figure 29. Calcite crystals from Pauchot artificial stone (view ESEM – sample 1)
