Introduction

The fibre glass industry uses Platinum-Rhodium alloys for their excellent mechanical and chemical properties at high temperature. These alloys are used for the bushing to pull glass fibres from molten glass.

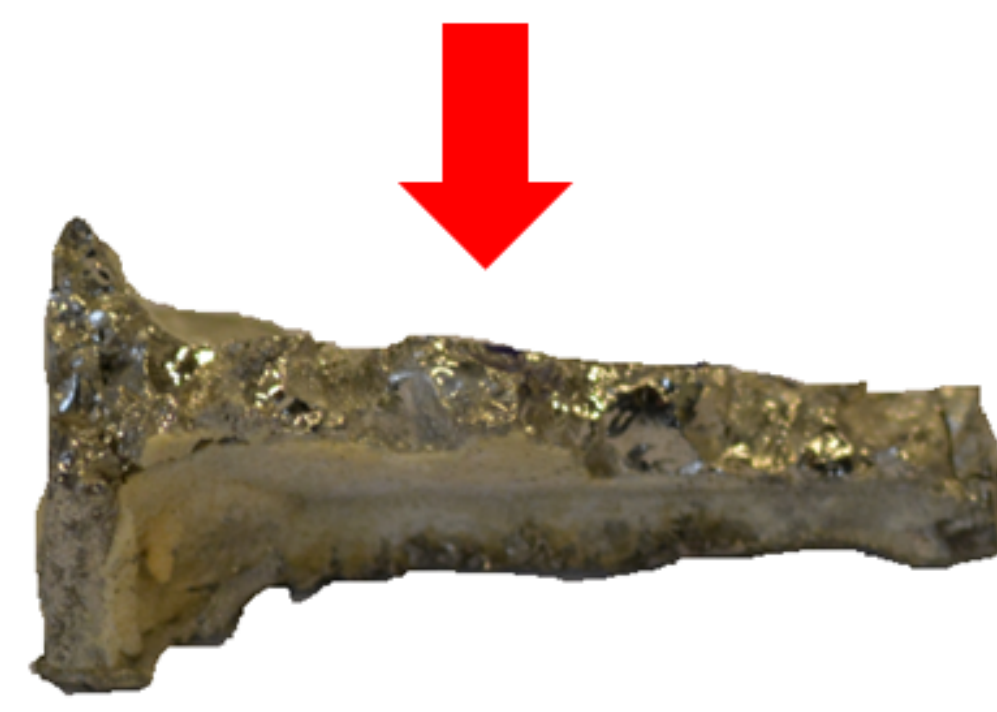
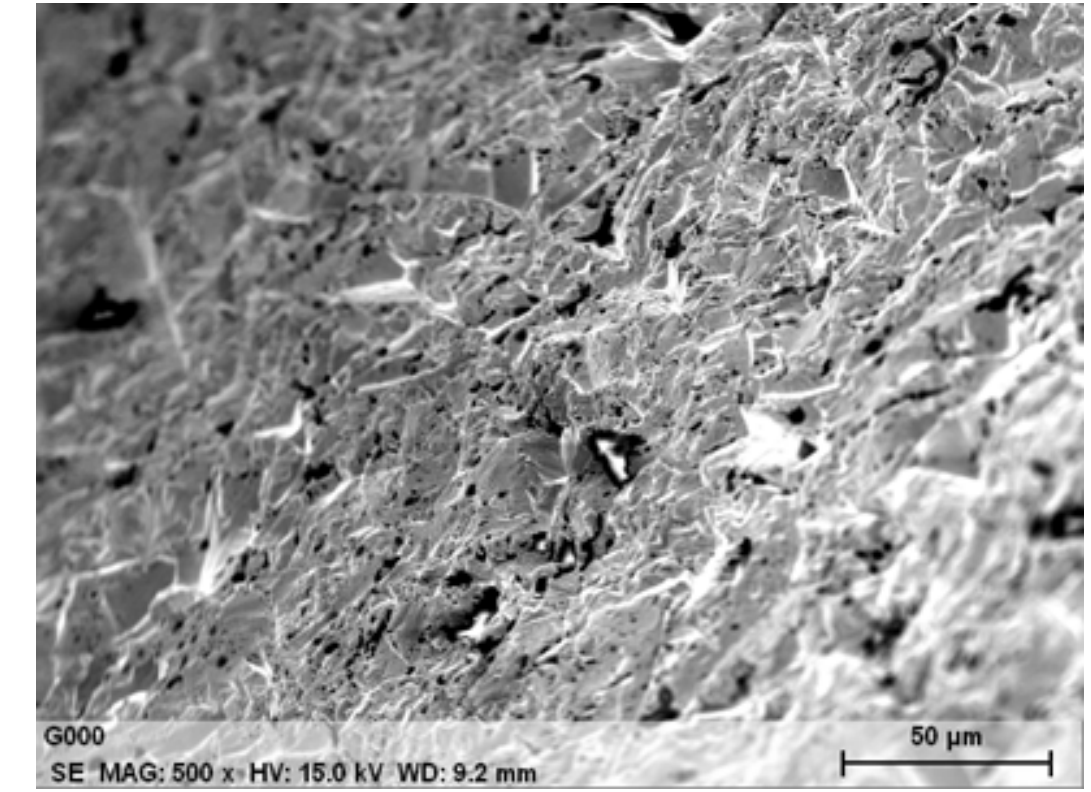
Fractography

Study of the fracture surface also gives us some informations. Unfortunately, in this specific case, the fracture surface is not the initial one but have been coated by condensated oxides during the manufacturing process.

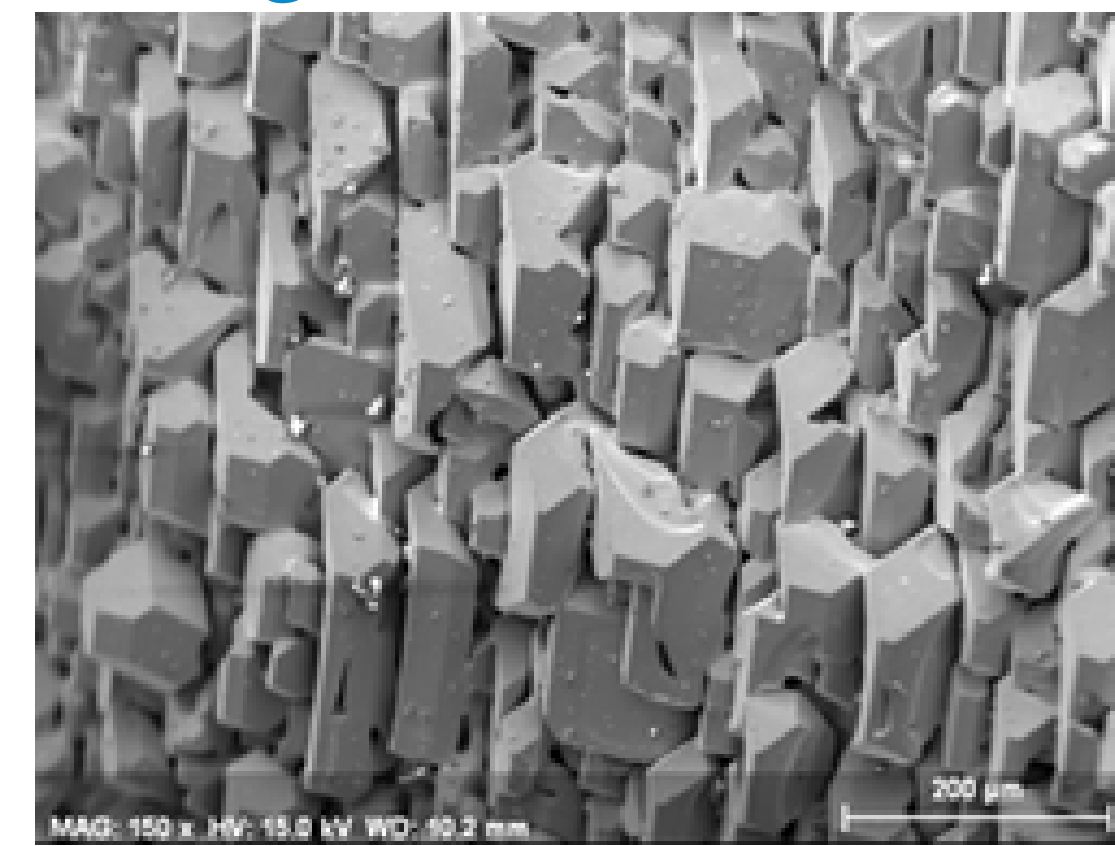
Hexagonal structure

Two different kinds of coatings (Pt-Rh based oxides) are observed:

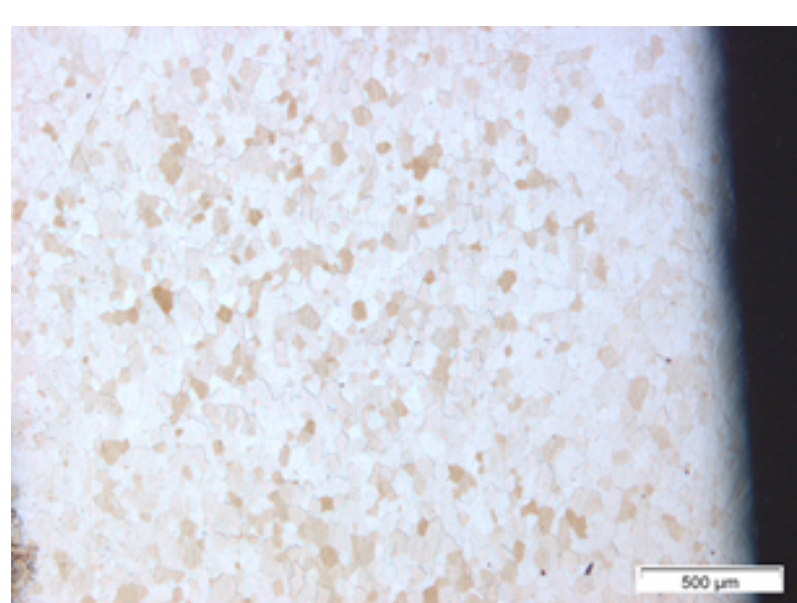
Base metal

→ MGS ~ 60 μm
→ 110 HV

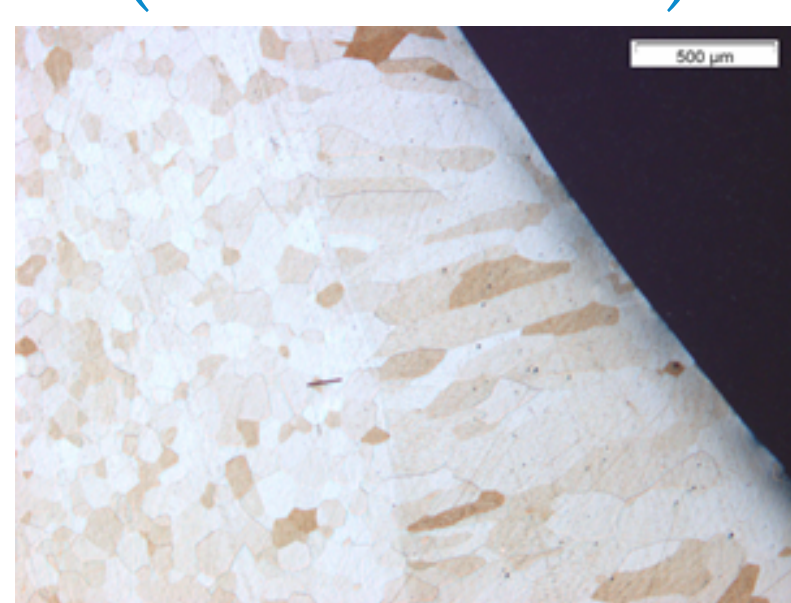
Welded area (critical zone)

→ MGS ~ 150 μm
→ 100 HV

- mean grain size is multiplied by a 2-3 factor compared to the base metal and welded area
- mean grain size of in-service metal is far above 500 μm
- no significant difference for Hardness Vickers values
- equiaxed grain morphology for the base and in-service metals
- columnar morphology in the welded zone: the grain are oriented along the thermal gradient during welding

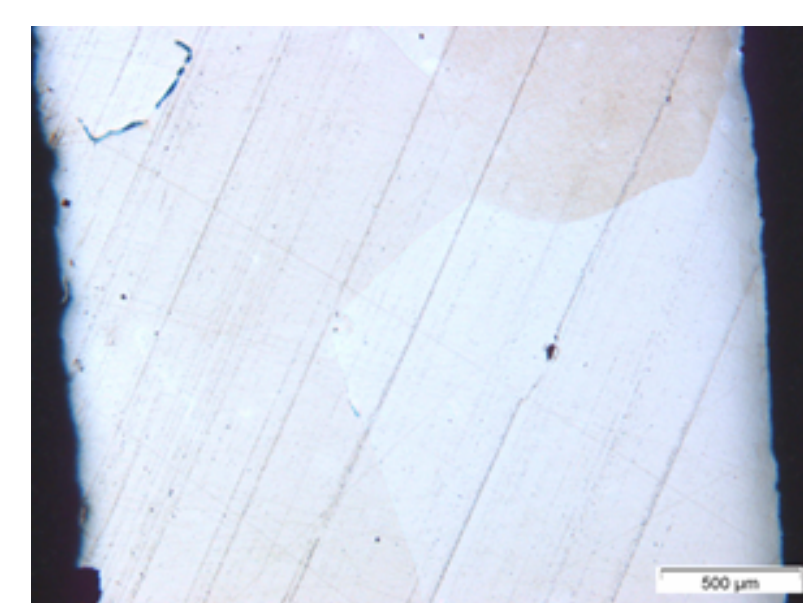
In-service metal

→ MGS ≥ 500 μm
→ 100 HV

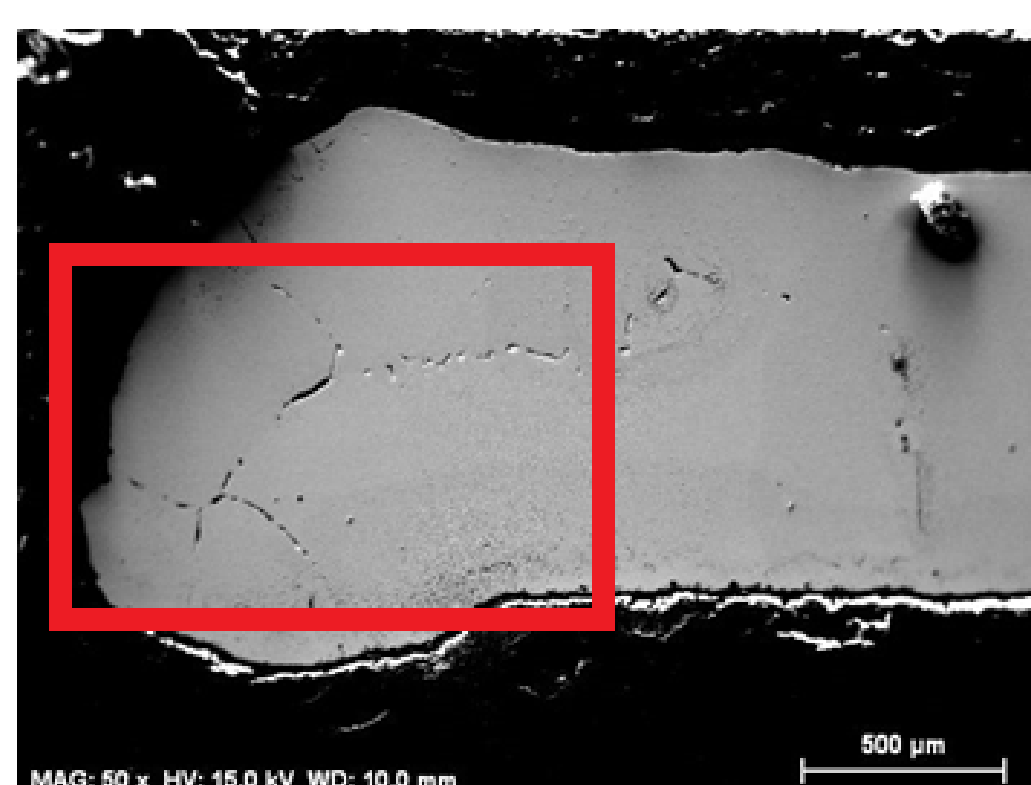
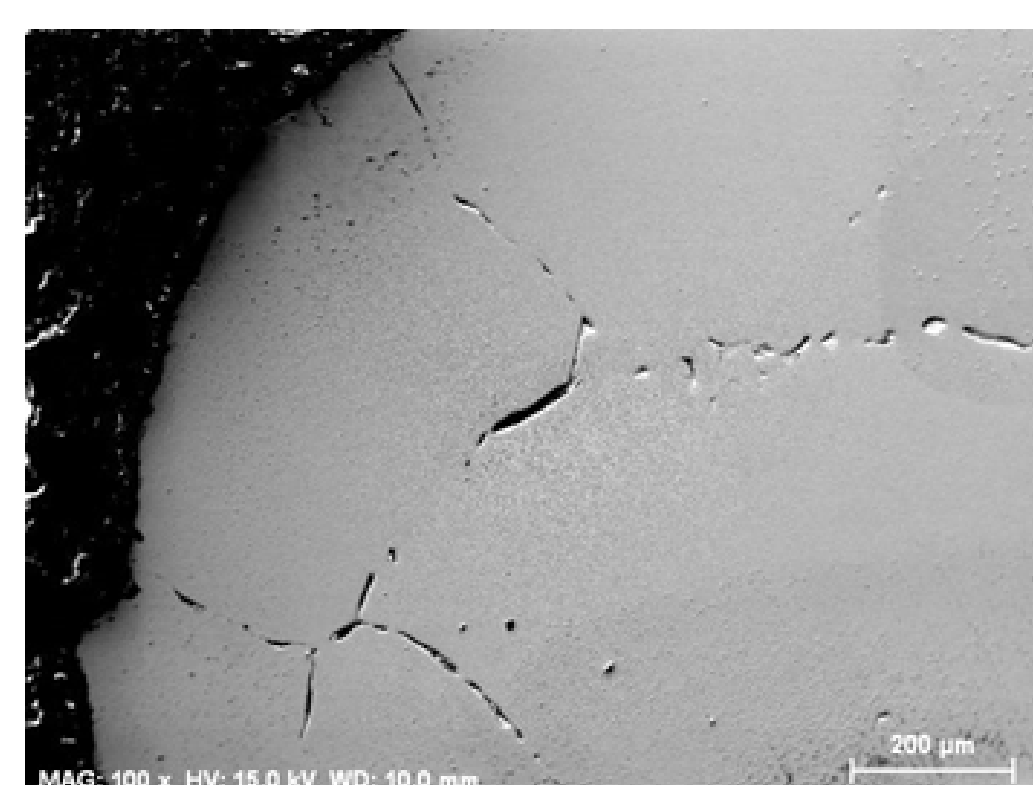
In-service metal

Deeper analysis made by electronic microscope highlights internal failure at grains boundaries.

→ Coarsed grains have intergranular cracks resulting from the interconnection of adjacent voids or holes located at the grains boundaries.

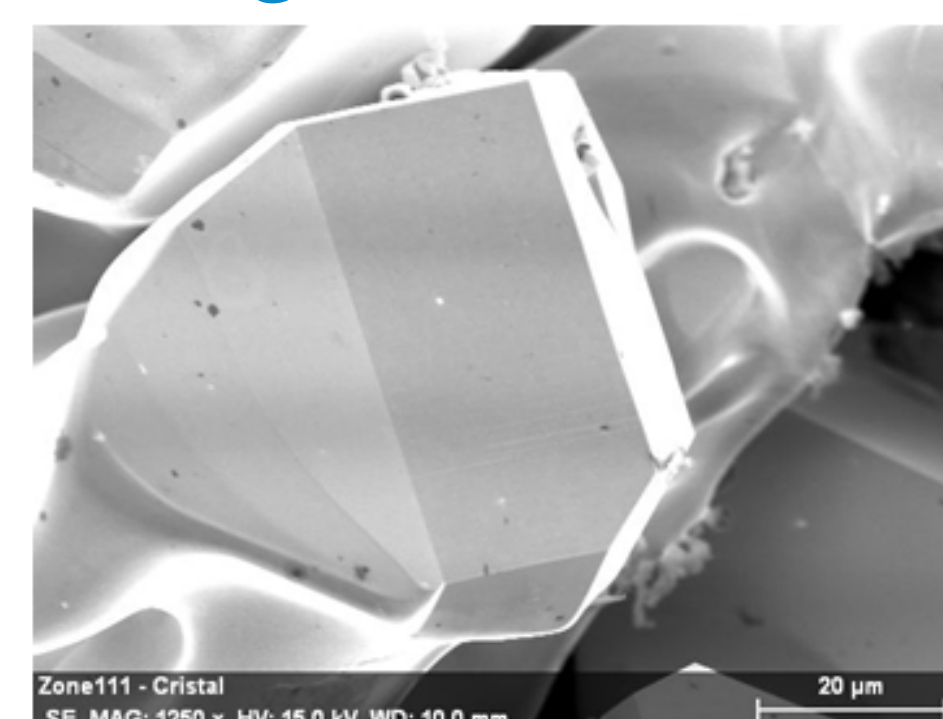
Hexagonal structure

Dust particles can be found along the tips on the bushing. Two possible origins:

- diffusion of metallic elements
- condensation and deposition of pre-evaporated oxides

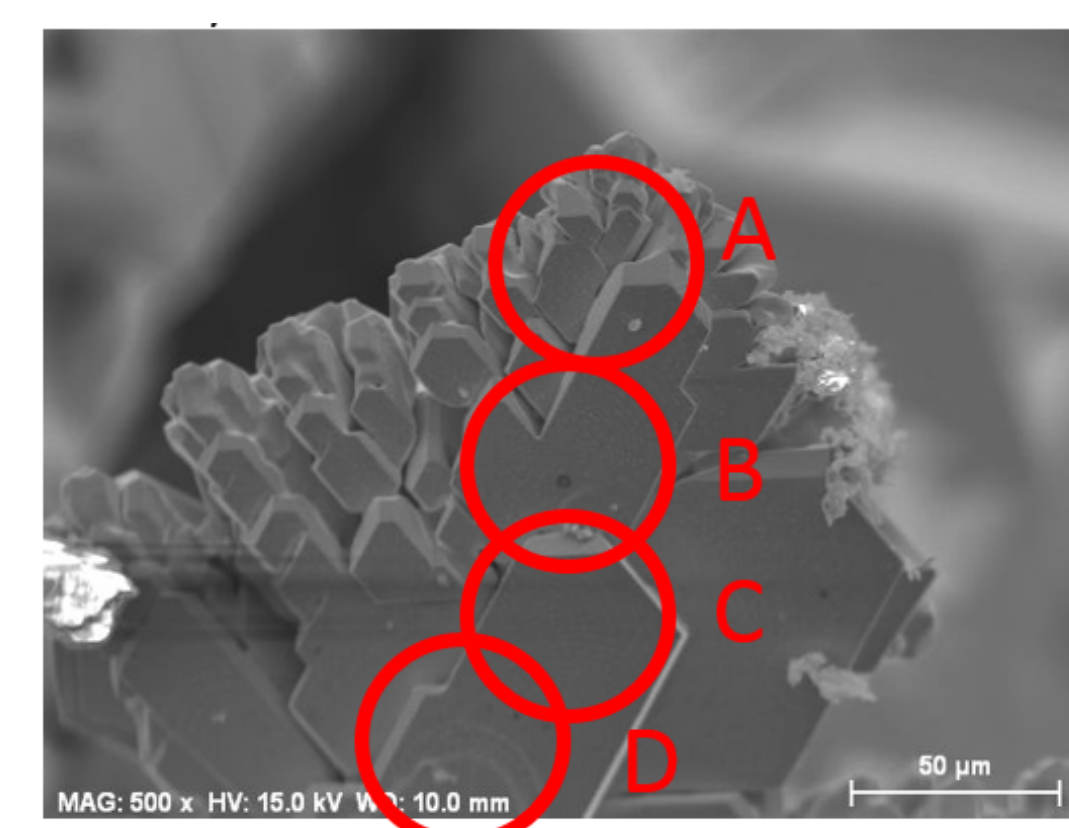
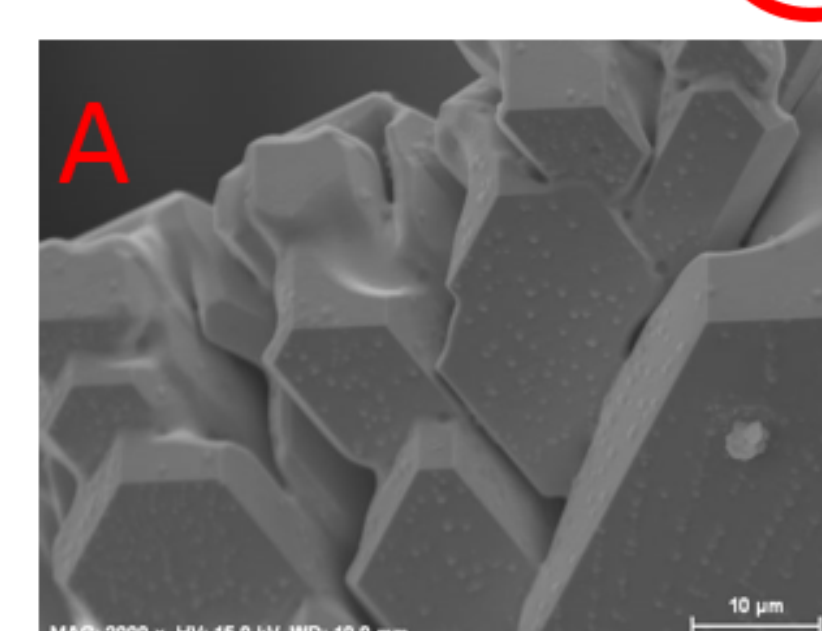
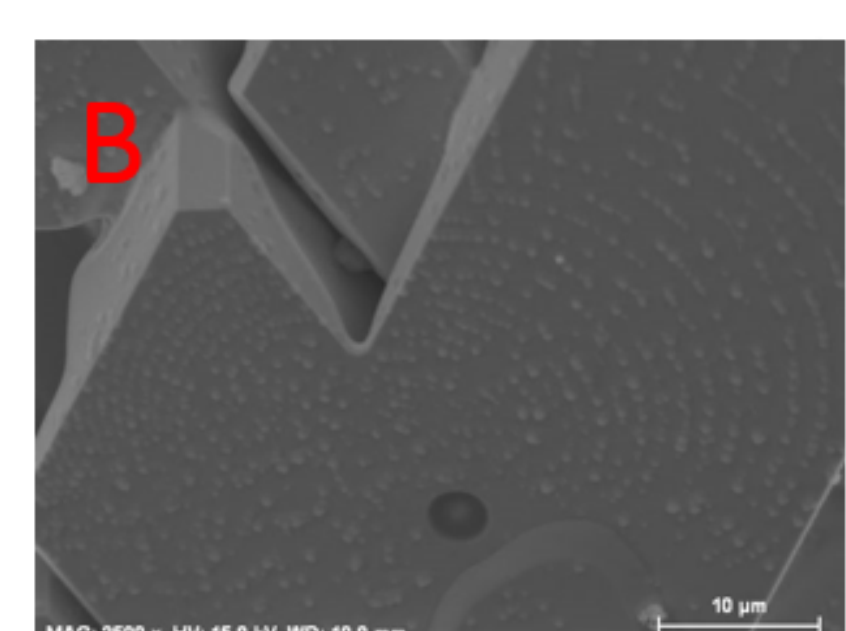
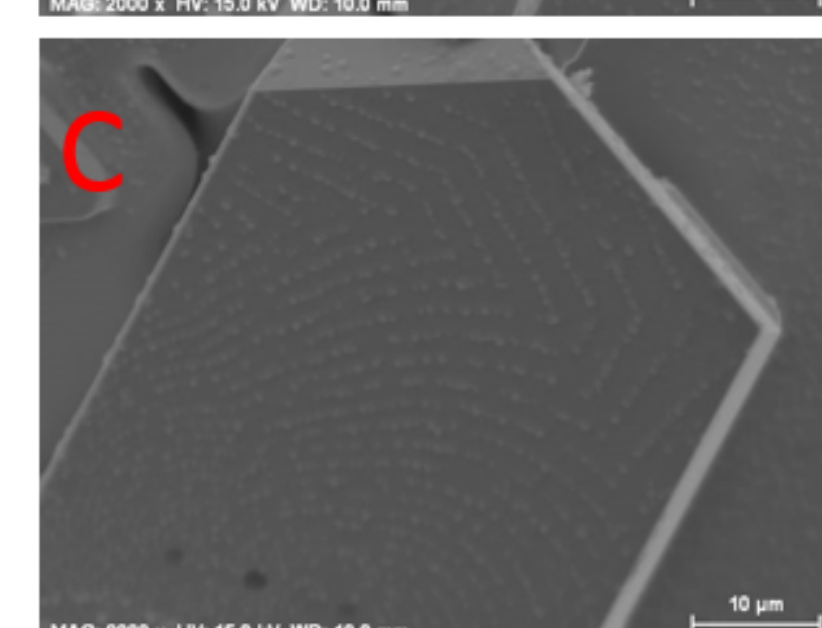
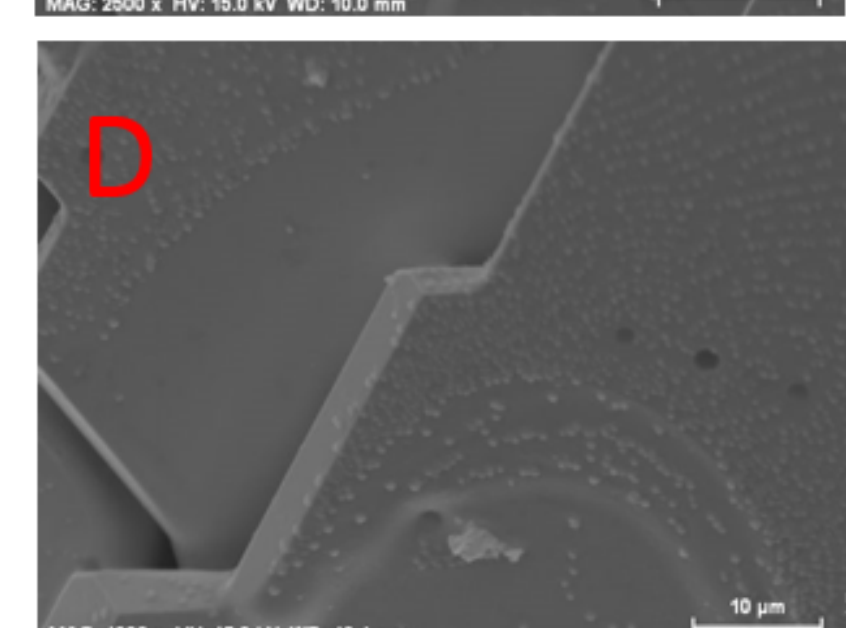
- with a faceted structure ...

→ multi scale crystal structure with ordered dots with a size around 1 μm
