Tachycardia during Coronary Computed Tomography Angiography

TIM COOLEN, M.S.,* OLIVIER GHEKIERE, M.D.,† JULIEN DJEKIC, M.D.,†
ISABELLE MANCINI, M.S.,† and ALAIN NCHIMI, M.D.†

From the *Université de Liège, Liège, Belgium; and †Department of Medical Imaging, Centre Hospitalier Chrétien, Liège, Belgium

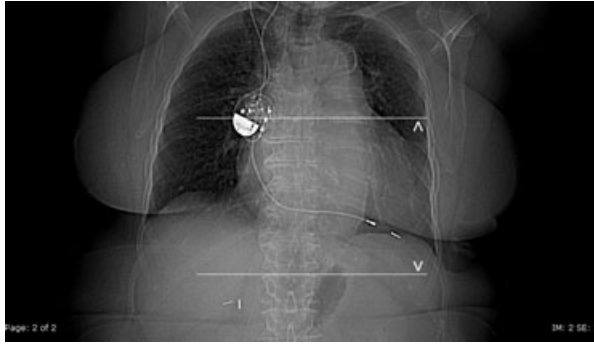
Fig. 1 shows the range of the CTA between the two horizontal lines, and Fig. 2 the electrocardiogram (ECG) trace obtained during image acquisition.

Figure 1. The range of the CTA between the two horizontal lines.

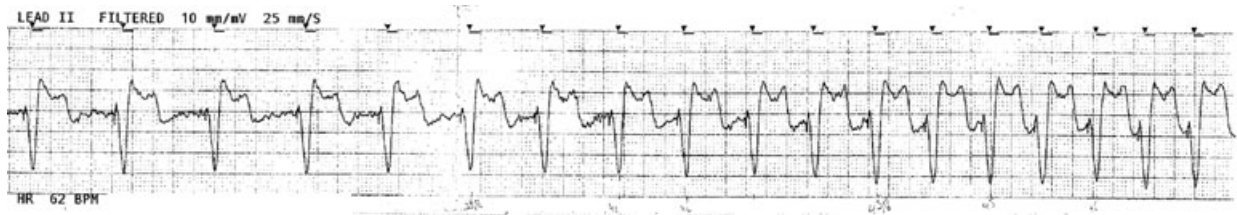
The baseline ECG displays a permanent AF and ventricular pacing at 60 bpm.

At the beginning of CTA, the heart rate (HR) rose from 60 bpm to a peak rate of 123 bpm in the span of 16 seconds. At all times, QRS complexes were preceded by a pacing spike.

Therefore, the x-ray-induced tachycardias in this patient most likely originate from an accelerometer sensor spurious signal, mimicking an important activity increase. This translated as a progressive tachycardia, which peaked after the termination of x-ray output and gradually subsided without any intervention. Indeed, the rate-responsive sensor of the patient’s pacemaker comprises a piezoelectric crystal and surrounding CMOS. The same argumentation as for the pulse generator piezoelectric crystal resistance to x-ray interference makes the dysfunction of this component of the accelerometer unlikely. However, occurrence of a SEE in the coupled CMOS would have been responsible for the particular kinetics of our patient’s tachycardia (i.e., the rapidly but gradually accelerating heart rate) that are compatible with the rate-response “fast” reaction settings. This has been acknowledged by the manufacturer as the most likely cause of our pacemaker dysfunction.⁹

Figure 2. The ECG trace obtained during image acquisition.

such as CTA, could benefit from temporarily switching off the accelerometer of rate-responsive pacemaker-implanted patients.
