Comparison of destructive methods to appraise the mechanical integrity of a concrete surface

L. Courard¹, B. Bissonnette², A.M. Vaysburd³, N. Béclair², and F. Lebeau¹

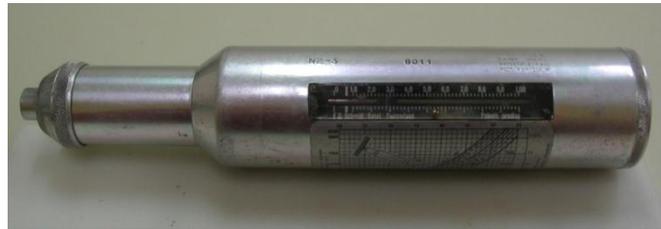
Due to its simplicity of use and low cost, the *Schmidt* rebound hammer (ASTM C 805) is a most widely used device for non-destructive testing of concrete (Fig. 1). It operates as follows: a spring-loaded hammer impacts with a given amount of energy a steel plunger in contact with the concrete surface, and the distance that the hammer rebounds is recorded. The rebound value is primarily influenced by the elastic modulus and strength of the concrete near the surface [6]. While the test may be simple to perform, the relationship between measured rebound and in-place concrete strength is sensitive to a number of parameters. In particular, the results are influenced by the moisture condition, carbonation and surface texture of the concrete, as well as hammer inclination [5-6]. Since the plunger's rebound depends on the energy being restituted from the substrate, it is expected that incidence of bruising and cracking in the surface layer will reflect in the recorded values. Although the evaluation of strength is not an issue in the present study, the test results are expressed in terms of strength.

Fig. 1 – The *Schmidt* rebound hammer

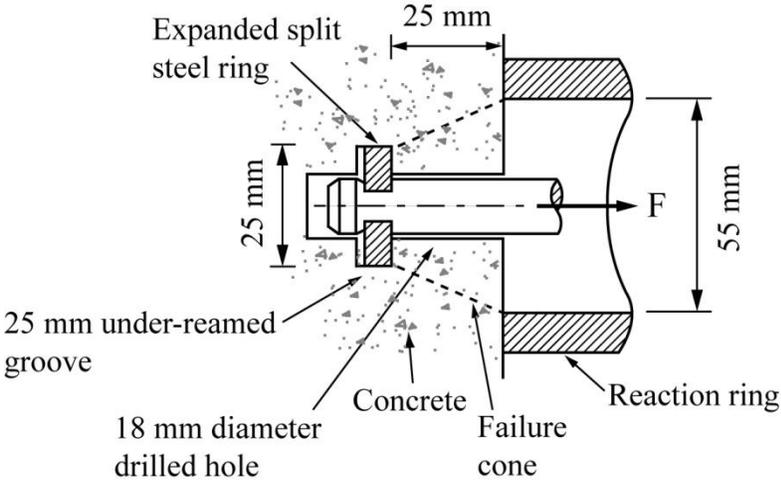
compressed steel ring to expand and confine the concrete (Fig. 2). The other investigated test, referred to here as the *Accelerated cohesion test*, is a non-standard procedure that uses a two component adhesive anchor consisting of a self-contained adhesive capsule and a threaded rod with nut and washer. For such experiments, it has been found that a minimum of 5 tests is recommended to yield reliable results [12].

Fig. 2 – Pullout - *Capo* test [13]

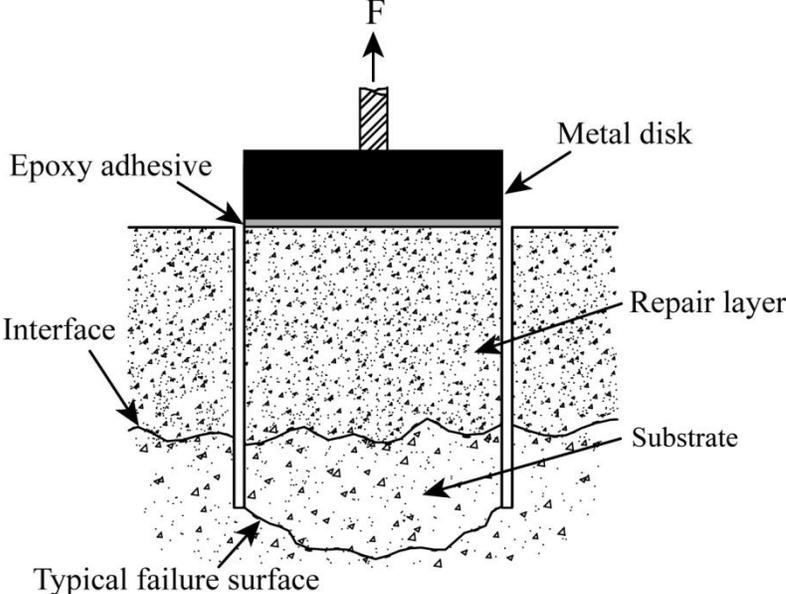
The pull off test is commonly used to assess the adhesion of repair systems to concrete. It measures the direct tensile force required to pull off a metallic disk, together with a layer of concrete, from the surface to which it has been epoxy-glued (Fig. 3).

Fig. 3 – Pull off test

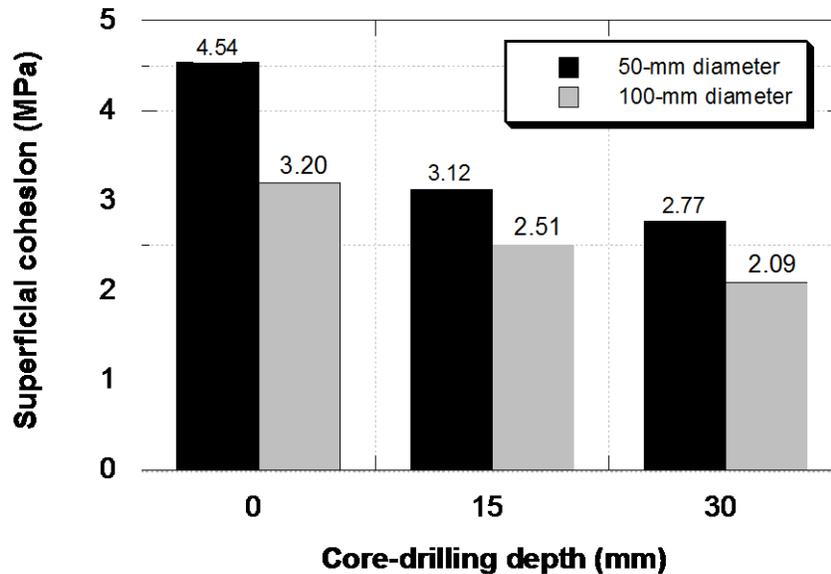
The pull off test can also be used to evaluate the cohesion and integrity of a concrete surface to be repaired [9-11,14-16]. An experimental program was conducted in a previous study [11] to evaluate the influence of various test parameters—metal disk thickness and diameter, core drilling depth, loading rate, adhesive type and thickness, and number of tests—to measure the cohesion of a reference concrete surface. A statistical results analysis revealed that disk diameter and core-drilling depth are the most significant parameters, presumably with threshold values (Fig. 4), which actually depend on the maximum aggregate size.

Fig. 4 – Effects of core-drilling depth and metal disk diameter on surface concrete cohesion (loading rate < 0.05 MPa/s)[11]

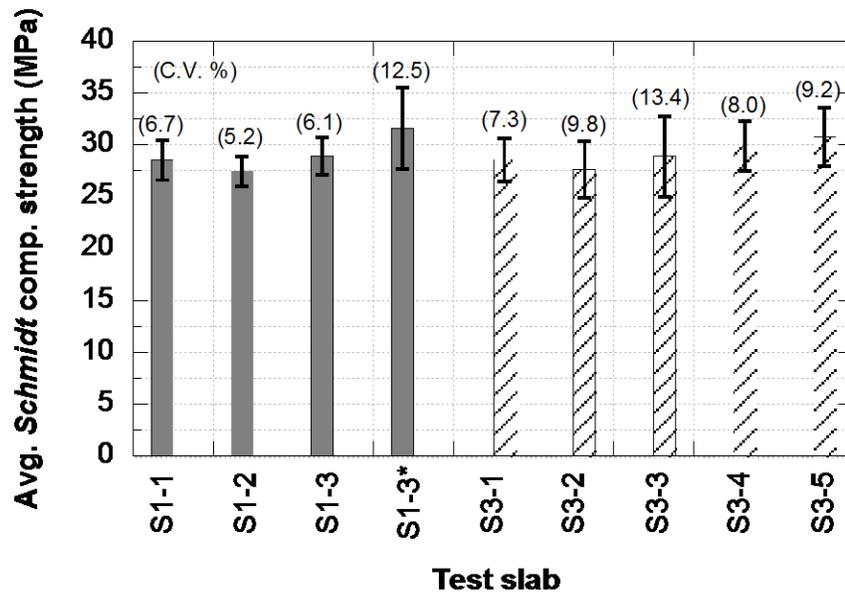
The *Schmidt* hammer results obtained for all concrete slabs are presented in Fig. 5. The differences between S1-3 and S1-3* appear to be mostly related to the nature of the support provided underneath the test slabs, either continuous (wooden platform) or discontinuous (2 wood ladders). Variability, which is evaluated with the coefficient of variation (CV), is lower when the concrete specimen is placed on a continuous support (Fig. 6).

Fig. 5 – Average compressive strength values estimated from the *Schmidt* rebound hammer tests on flat finished slab specimens

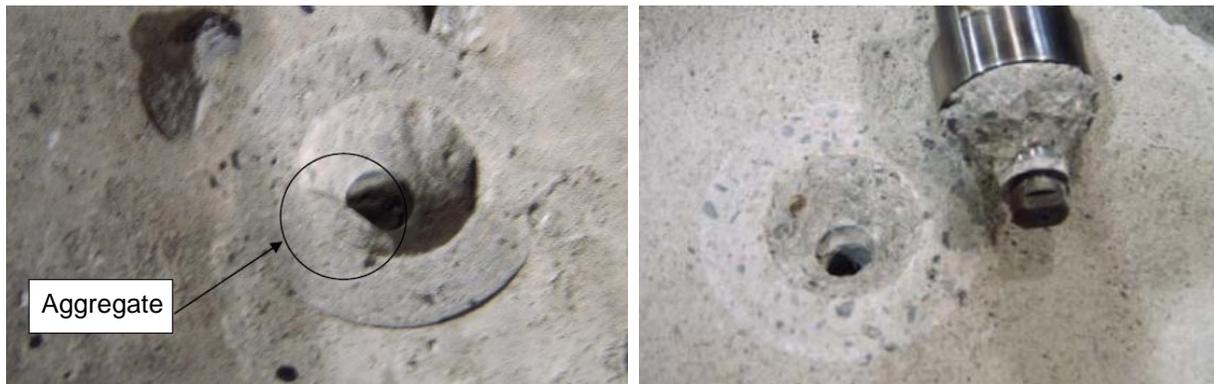
Strictly from the test result data, no specific trend could clearly be associated to the coarse aggregate size. Nevertheless, the observation of the extracted concrete fragments (conical-shape failure) revealed that larger aggregate size in S1-series slabs altered the cracking pattern, resulting in a much more irregular conical shape (Figure 6 a) and b)).

a) S1-series slab

b) S2-series slab

Fig. 6: Typical pullout conical-shape failure after *Capo* pullout tests

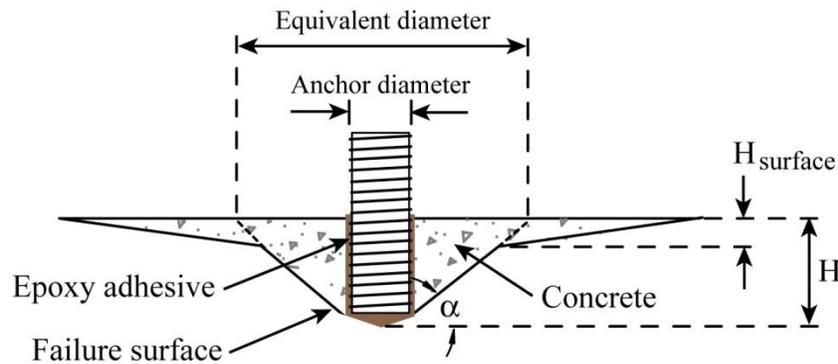
1. Type 1: The failure mode is characterized by anchor extraction with little or no concrete near the surface. This can be the result of insufficient polymerization of the adhesive or by the presence of interfacial defects (air bubbles or lack of adhesion between adhesive and concrete), which cause a weak bond between the adhesive and concrete and ultimately trigger failure.
2. Type 2: The failure mode leads to the extraction of a cone-shaped concrete fragment along with the anchor. This type of rupture is known as *conical-shape* failure. Fig. 7 illustrates this type of failure and the corresponding geometrical parameters. In many cases, the extracted cone exhibited two segments, the angle α decreasing sharply near the surface.

Fig. 7 – Schematic diagram of the conical-shape failure observed in *Accelerated cohesion* tests

In order to compare the results of the pull off and *Accelerated cohesion* tests, the surface area of the failure cone in the latter was evaluated to determine the effective tensile cohesion stress. The tensile load-bearing surface was calculated by evaluating the horizontal projection of the cone area, less the steel anchor cross-section. In determining the equivalent diameter at the surface, the assumption was made that the cone angle (α) was constant from the bottom up to the surface (enlargement near the surface neglected). Equivalent surfaces and corresponding stress values for tests conducted with 9.5-mm diameter anchors at a depth of 20 mm are presented in Tables 7 and 8.

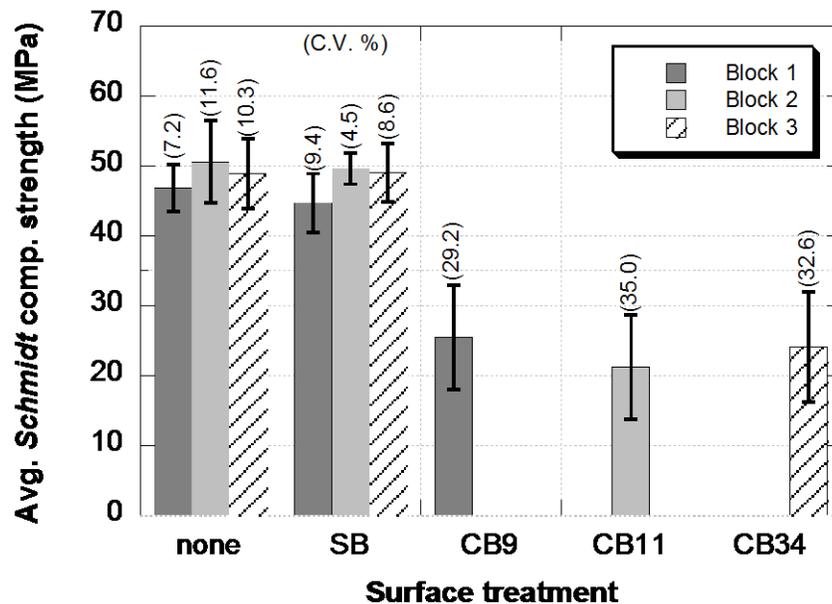
Figure 8 presents the average results and coefficients of variation respectively of the *Schmidt* hammer soundings performed on all testing surfaces (avg. of 60 results for ref. and SB treatment; avg. of 25 results for CB treatments).

Fig. 8 – Average compressive strength values estimated from the *Schmidt* rebound hammer tests on slab specimens after different surface treatments (SB: sandblasting; CB9: 9-kg concrete breaker; CB11: 11-kg concrete breaker; CB34: 34-kg concrete breaker)

Again, the compressive strength values calculated from the recorded *Schmidt* hammer rebound data are strictly used here on a comparative basis. As shown in Figure 8, the results obtained for the surfaces prepared with concrete breakers exhibit much more variability, which can be attributed to the following:

Although this test can yield significant average values when performed over large surfaces, the data recorded in the present study suggest that variability, not in as much as the absolute values, provide a reliable indication of the presence and importance of defects in the substrate. Based upon the results generated with the various investigated surface preparation methods (see Table 3, Figs. 5 and 8), it appears that a threshold C.V. value of the order of 15 to 20 % could discriminate between prepared surfaces where significant bruising has been left or not.
