1           **EFFECT OF MISALIGNMENT ON PULL-OFF TEST RESULTS:**  
2           **NUMERICAL AND EXPERIMENTAL ASSESSMENTS**

3                           L. Courard, B. Bissonnette, A. Garbacz, A. Vaysburd,

3 The successful application of a concrete repair system is often evaluated through pull-off  
4 testing. For such *in-situ* quality control (QC) testing, the inherent risk of misalignment might  
5 affect the recorded value and eventually make a difference in the acceptance of the work. So  
6 far, the issue of eccentricity in pull-off testing has been ignored in field practice, because it is  
7 seen as an academic issue. This paper presents the results of a project intended to quantify the  
8 effect of misalignment on pull-off tensile strength evaluation and provide a basis for  
9 improving QC specifications if necessary. The test program consisted first in an analytical  
10 evaluation of the problem through 2-D FEM simulations and, in a second phase, in laboratory  
11 experiments in which the test variables were the misalignment angle (0°, 2° and 4°) and the  
12 coring depth (15 mm [1.18 in.], 30 mm [2.36 in.]). It was found that calculations provide a

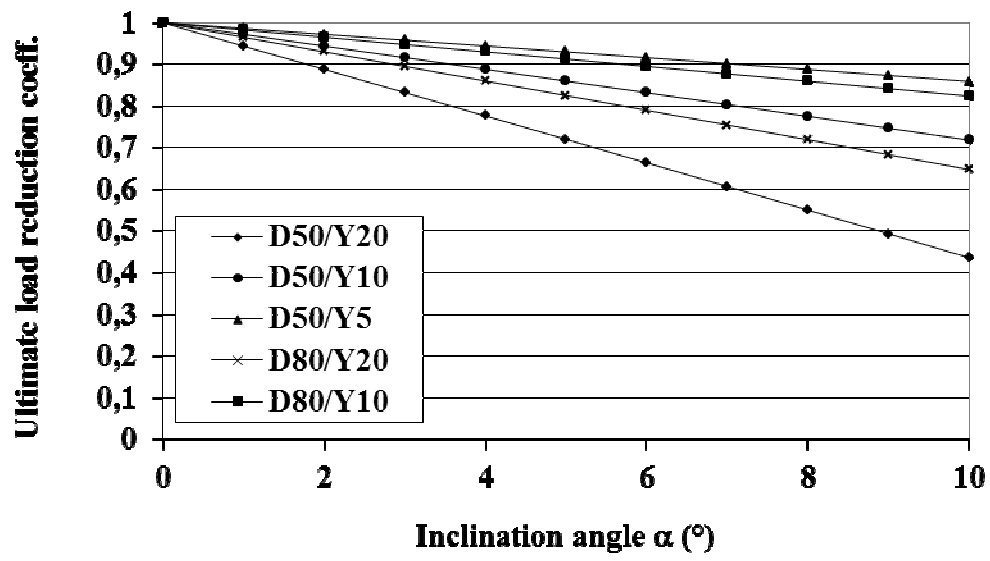
1 Fig. 2–Influence of the load inclination (from Cleland et al.<sup>15</sup>).

2 where  $\alpha$ ,  $D$ ,  $y$  are the angle of inclination of the coring axis (with respect to an axis  
3 normal to the surface), the core diameter, and the coring depth respectively, as shown in Fig.  
4 2.

5  
6 Misalignment in pull-off tests may have a substantial influence upon test result for angles of  
7 inclination of more than  $5^\circ$  (Fig. 2). Reduction in core depth or increase in dolly diameter  
8 tends to minimize the negative effects of misalignment. It should be stated, however, that the  
9 above conclusions are strictly theoretical in nature, as they do not take into account such  
10 factors as potential stress relaxation and the possibility that the core brittle zones are not  
11 necessarily corresponding to the stress concentration zones.

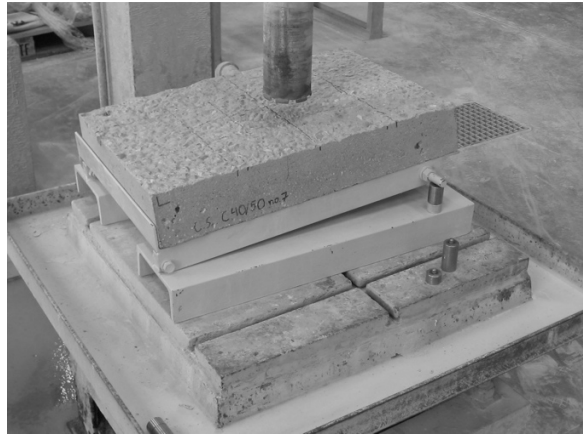
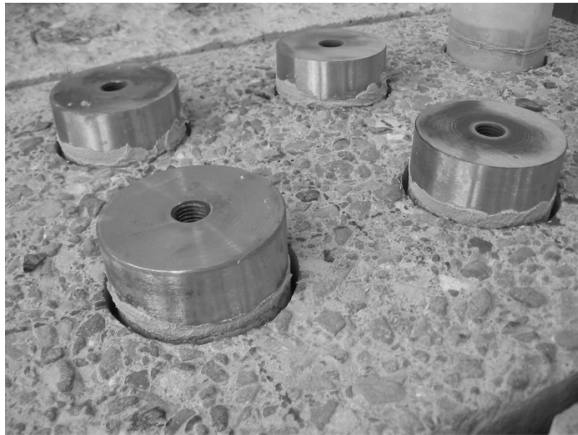
Fig. 6–Pull-off test preparation.

a) Special device for controlling the coring axis inclination

b) Slab positioning for coring at an angle of 4°

c) Dolly installation

d) Positioning of the pull-off test device

12 As in the numerical analysis, the tensile pull-off tests were conducted on test specimens  
13 prepared with different core depths and inclinations. Core depths of 15 mm [1.18 in.] and 30  
14 mm [2.36 in.] and coring axis inclination angles of 0°, 2° and 4° were again investigated. The  
15 different core inclinations were achieved using the special device shown in Fig. 6 a), which  
16 allows controlling the inclination of the core drill axis (Fig. 6 b)) with a precision of 0.1°.  
17 Taking into account the maximum aggregate size of the concrete mixtures (20 mm), 80-mm  
18 diameter cores were drilled for pull-off testing (80 mm diameter and 30 mm [2.36 in.] thick  
19 steel dollies). Steel dollies were carefully installed using epoxy resin (Fig. 6 c)) and the pull-  
20 off test device was then positioned on the concrete substrate (Fig. 6 d)).<sup>12</sup> Prior to testing, the  
21 adhesive was allowed to cure for 24 hours. Once the testing rig was installed and connected
