Pathologies of concrete in Saint-Vincent Neo-Byzantine Church and Pauchot reinforced artificial stone

This article focuses on the Saint-Vincent Church, Liege district, Belgium. With concrete as major building material, this was built in only 20 months, from 1928 to 1930. This monumental building, from Neo Byzantine style, however presents some degradations. A visual inspection, as well as non destructive and laboratory tests, are presented and analysed. They help to make a clear diagnosis and to assess hypothesis on the real state of this high-quality architectural building. Moreover, specific investigations have been realized on a special mortar used for wall construction: Pauchot reinforced artificial stone.

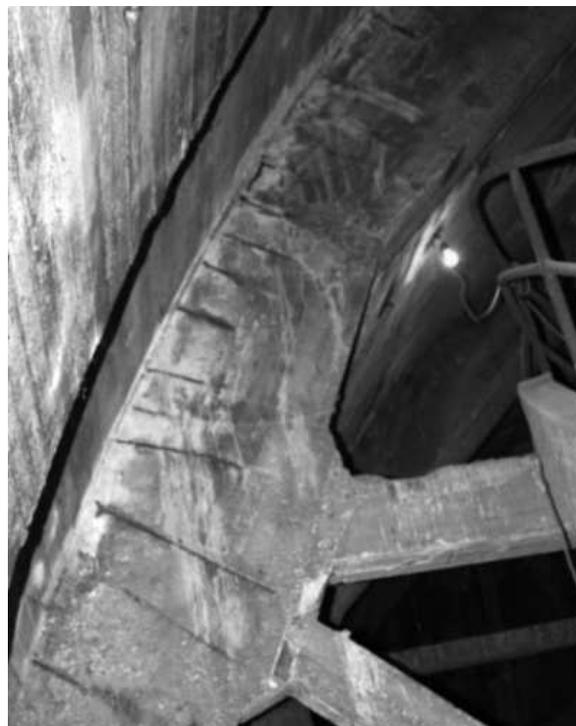
Archives shows that concrete was directly cast on the site and that traditional wooden plank sheeting (Figures 10 and 11) were used for casting; the absence of spacers resulted, in some cases, the positioning of the frame very close to the surface (Figure 13).

Figure 13. Reinforced concrete frame structures (between dome shells)

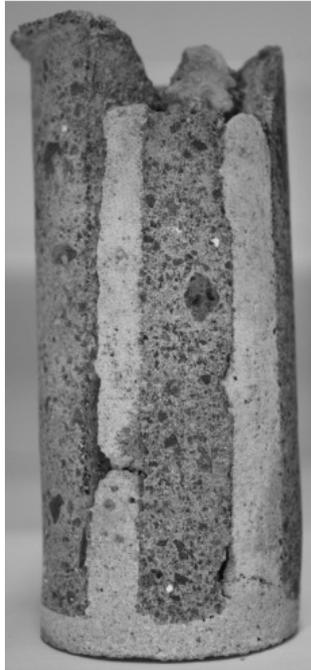
- a wall (apparently made of blocks) of concrete, 16 cm thick (Figure 14);
- a vacuum of 13.5 cm thick;
- Pauchot reinforced artificial stone, about 12 cm thick (Figures 15 and 16).

Figure 14. Sample of concrete (internal wall, Saint-Vincent church)

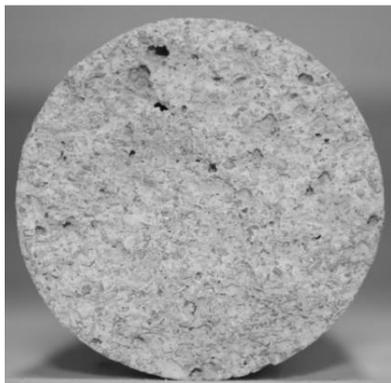
Figure 15. Internal face of Pauchot reinforced artificial stone sample from Fig. 14 (Saint-Vincent church)

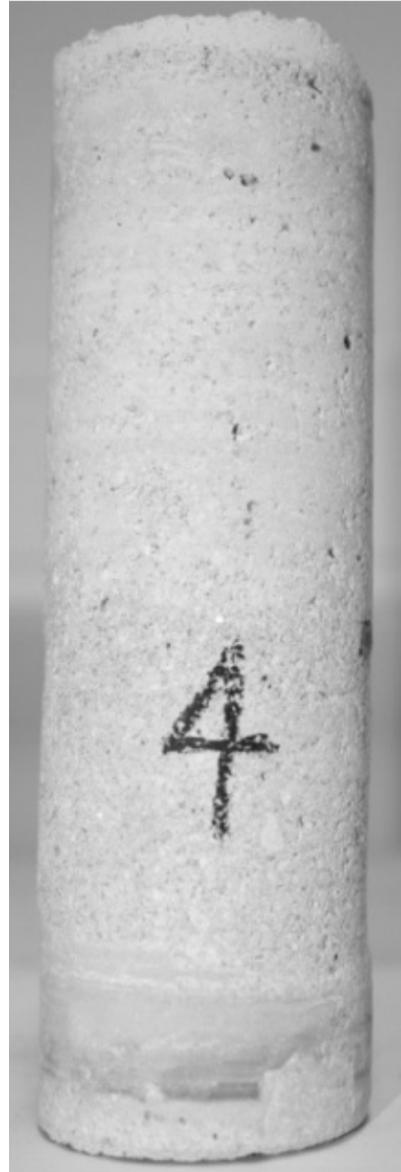
Figure 16. Sample of Pauchot reinforced artificial stone (external wall, Saint-Vincent church)
