Introduction

The fibre glass industry uses Platinum-Rhodium alloys for their excellent mechanical and chemical properties at high temperature. These alloys are used for the bushing to pull glass fibres from molten glass.

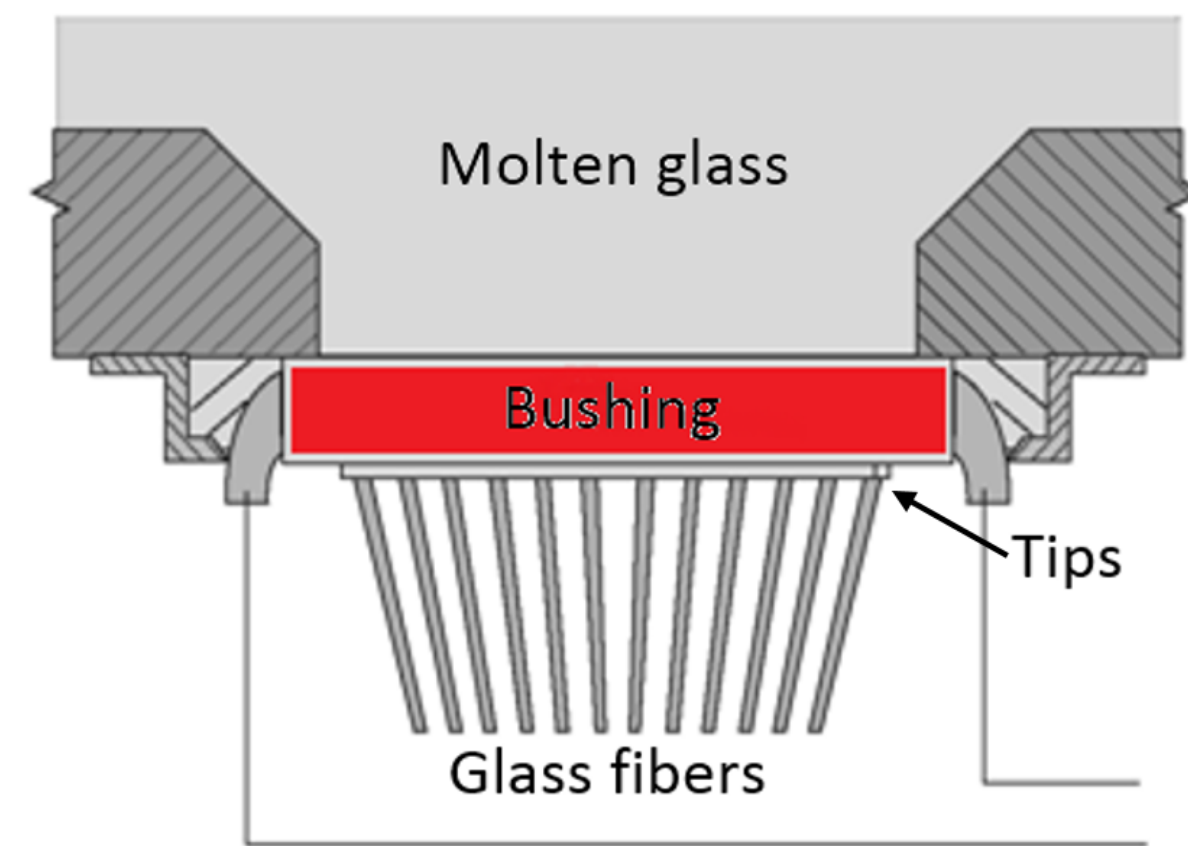
There are two different kinds of problem which limit the lifetime of a bushing:

1. the **damage propagation problem**: the bushing tends to failure until its decommissioning
2. the **metal operating losses**: the high level of temperature (1300°C) induces the creation of volatile oxide and so loss of mass.
